FINAL REPORT
FOKKER F-28 MK 0100, XY-AGC
ACCIDENT NEAR HEHO AIRPORT (VYHH)
ON 25 DECEMBER 2012

FOKKER F-28 MK 0100, XY-AGC **ACCIDENT NEAR HEHO AIRPORT (VYHH)** **ON 25 DECEMBER 2012**

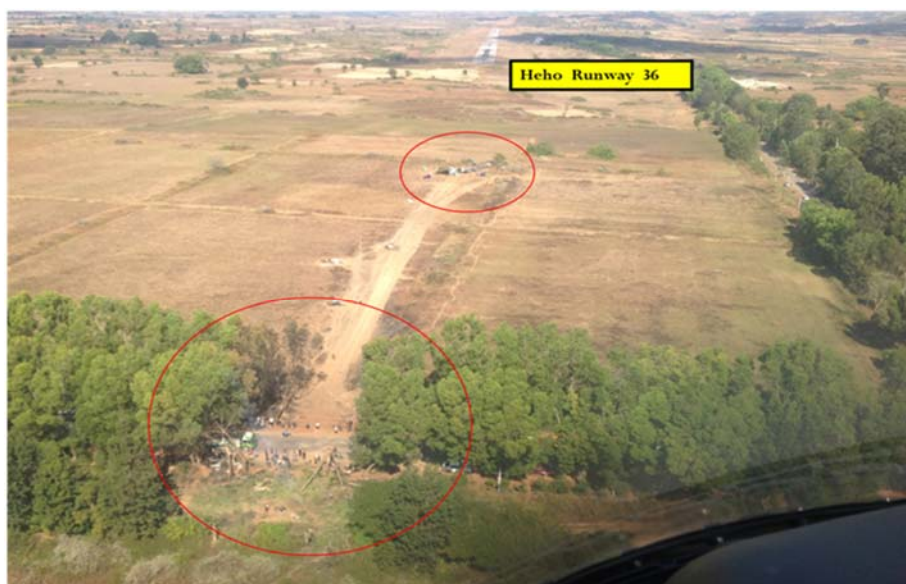
During the final inbound track at about 2.5 NM to the runway at 08:52:34, the EGPWS aural warning called out "500". The Pilot in command initiated "Alt hold" at about 0853, Just before the EGPWS alert "100" "50" "40" "30" and the aircraft struck 66 KV power lines, trees, telephone cables, fence and collided with terrain short of the runway, coming to rest approximately 0.7 NM from the threshold. During the ground collision, both wings separated and a fire commenced almost immediately. An emergency evacuation was initiated by the cabin crews. One aircraft occupant and one motorcyclist on the ground were fatally injured, 70 of the occupants and one motorcyclist survived and the aircraft was destroyed by fire.

Figure 3: Accident site

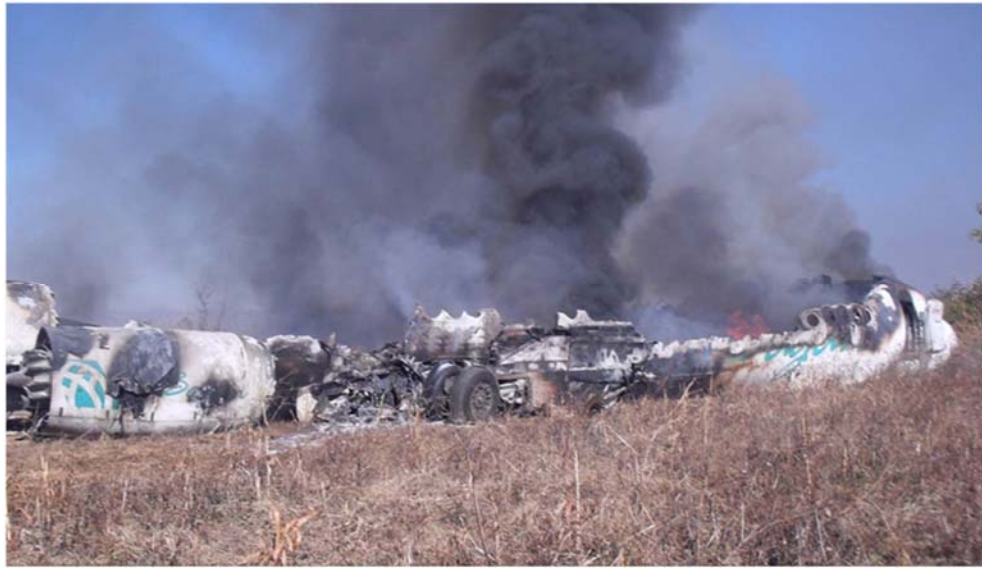
Both wings had separated before the aircraft came to rest. The main fuselage, both engines and the landing gear remained together. The tail assembly had detached but remained connected to the fuselage by the flight control cables. The remainder of the aircraft was subsequently destroyed by fire.

Figure 4: Damage to Aircraft

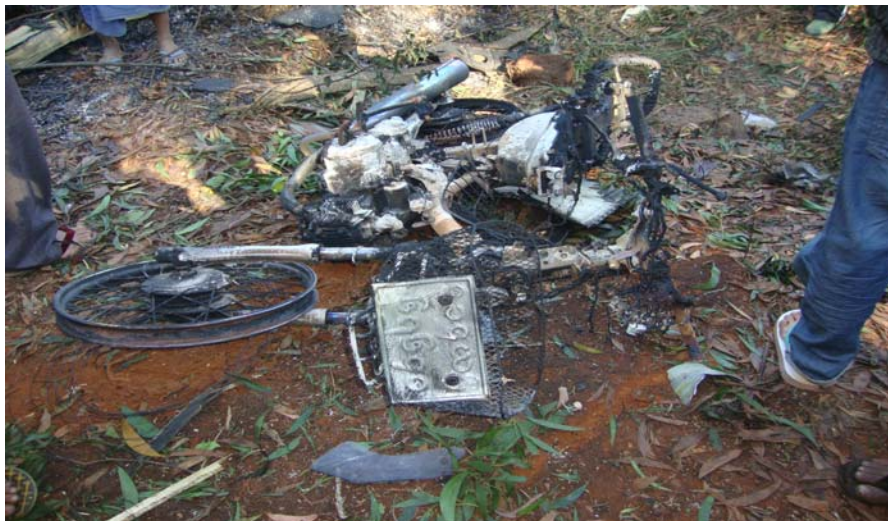
There was other damage to a 66 KV power lines, trees, 11 KV power lines, telephone cables, a fence and a motorcycle. As the aircraft struck the trees, a motorcycle with two motorcyclists passing on the road, aircraft debris struck the motorcycle. The motorcycle was destroyed.

Figure 5 : Damage to motorcycle

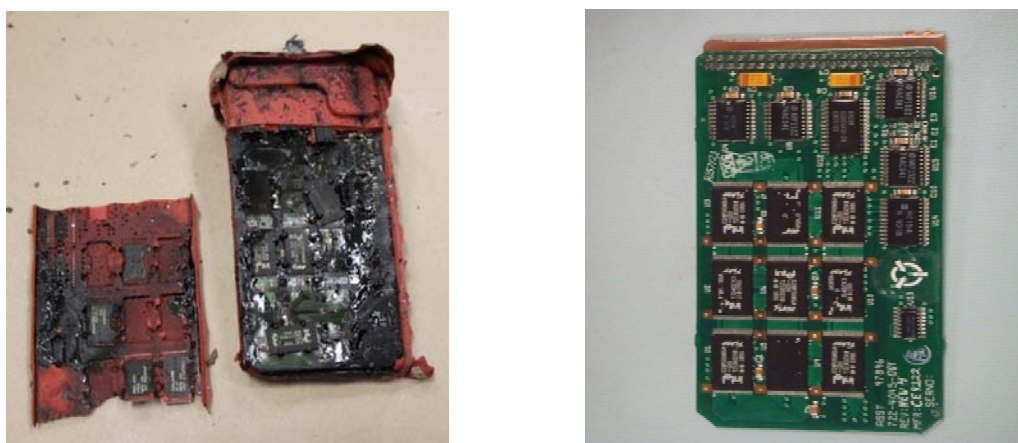
The SSUFDR's construction was outer steel housing, insulation liner, thermal block and memory board with 9 chips. The SSUFDR was severely burnt during the post-impact fire and significantly damage by fire. SSUFDR circuit board was removed at ATSB Lab. It is required special techniques to recover the recorded information. ATSB contacted to manufacture Honeywell and with the instruction of Honeywell carefully removed each chip from circuit board and downloading. A track plot of the flight is contained in figure and recorded information from the flight is included in **(Appendix-D)**.

Figure 6 : FDR memory module (accident module on left, normal module on right)

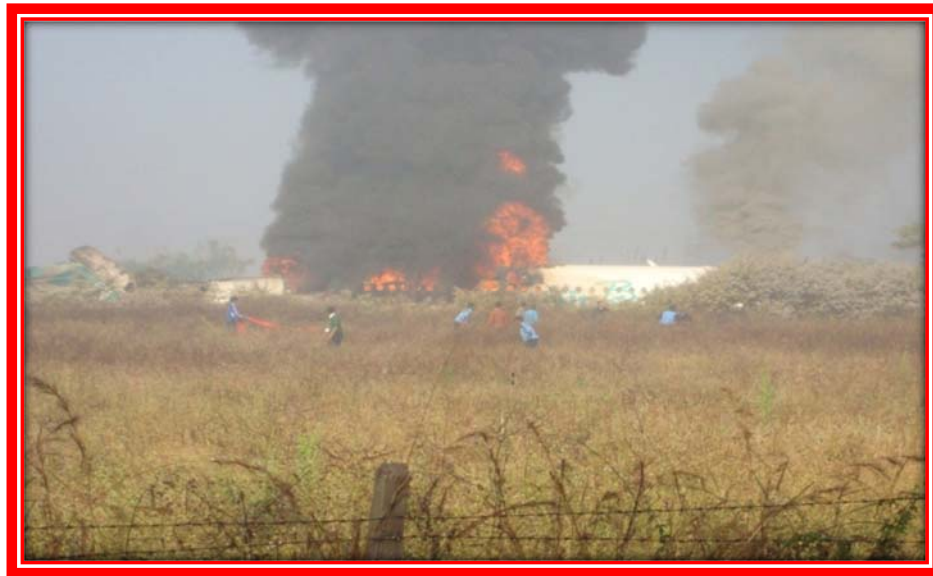
Both of the wings were broken off by the trees that the aircraft fuel tanks were disrupted during the impact sequence. The aircraft fire was initiated by electrical arcing and / or ignition of the residual fuel. There was no evidence of an in-flight fire.

Figure 8: Fire Fighting

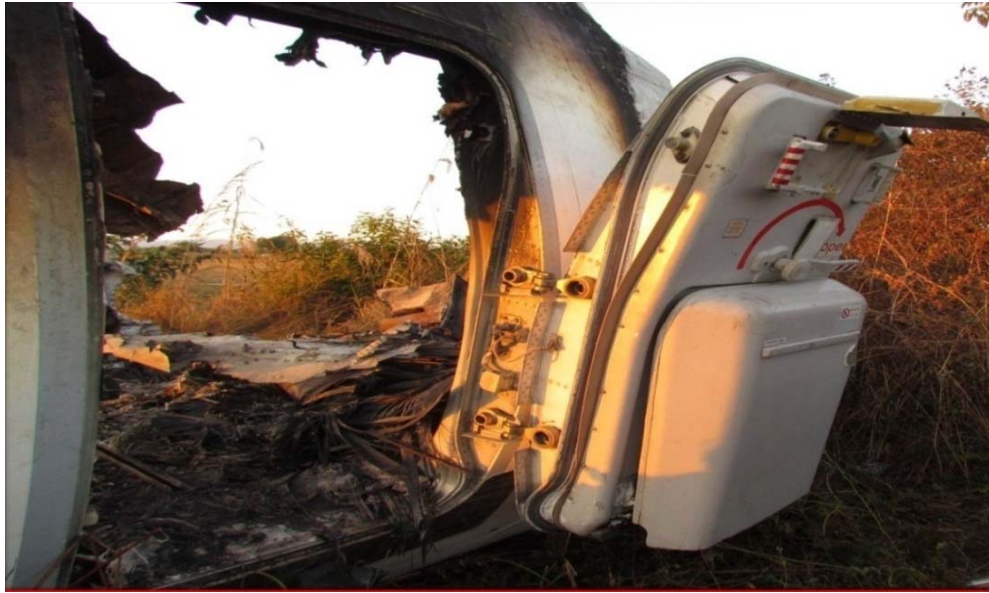
The forward cabin door left door slide activated and deployed but the cabin crew deactivated the service door slide on the right side, due to the close proximity of the ground and so it was not deployed.

Figure 9 : Forward cabin door (right side)

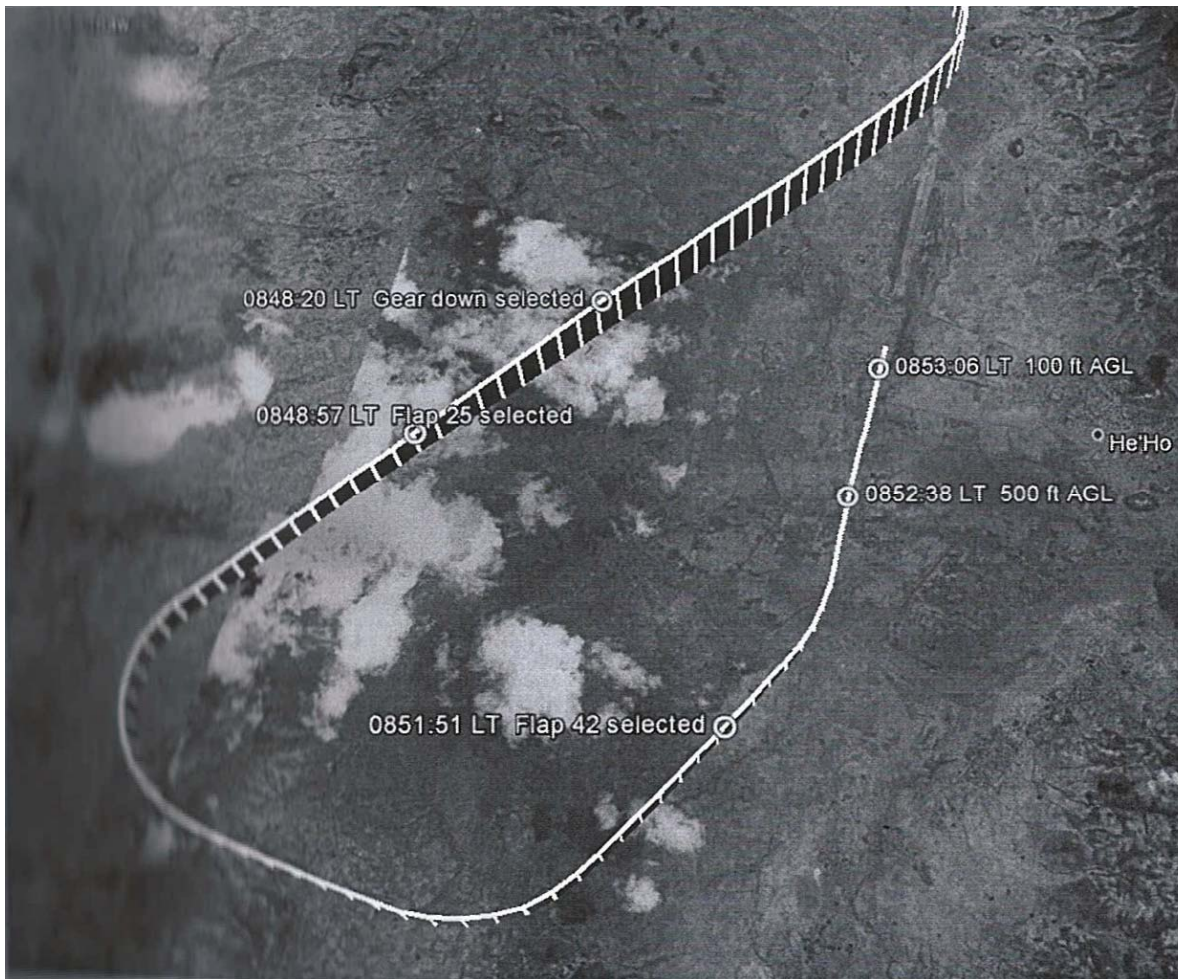
FDR and CVR data showed the accident flight path to Heho airport. The layout of Heho airport was examined and geographic features was used to plots flight path. **(Appendix-D)**

Figure 10: Vertical flight path Heho
