FINAL REPORT
FOKKER F-28 MK 0100, XY-AGC
ACCIDENT NEAR HEHO AIRPORT (VYHH)
ON 25 DECEMBER 2012

FOKKER F-28 MK 0100, XY-AGC **ACCIDENT NEAR HEHO AIRPORT (VYHH)** **ON 25 DECEMBER 2012**

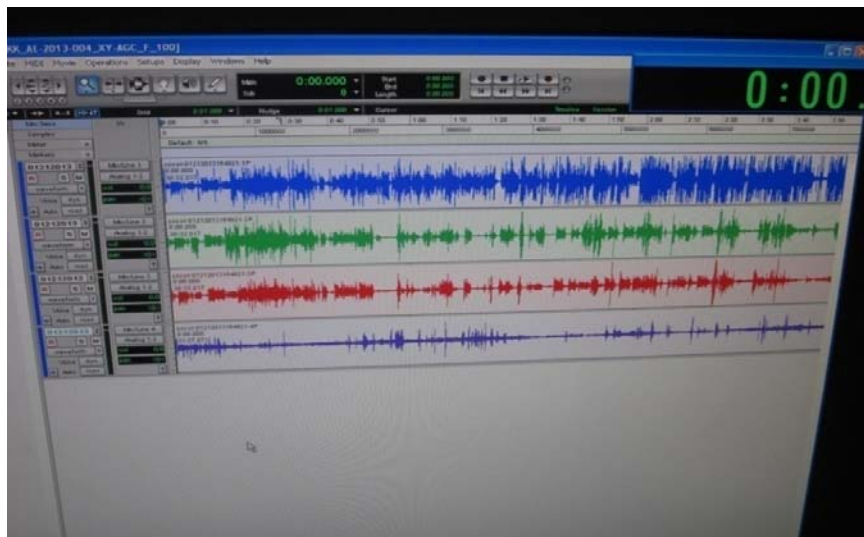
Figure 7: Cockpit Voice Recorder Downloaded

The SSCVR data was downloaded at ATSB. According with the downloaded data, FO was the designated handling pilot for this flight. While approach to MDA, the PIC reported to ATC about fog layer between the aircraft and runway. During the final approach, GPWS call out alert warning sound to crews with "500" "100" "50" "40" "30". PIC initiated to "Alt Hold" at about MDA 100 ft. The CVR transcript at **(Appendix-E)**.
